Site Hazard Assessment Worksheet 1 Summary Score Sheet

Pillon Property

This site was assessed for the February 2016 update of the Hazardous Sites List.

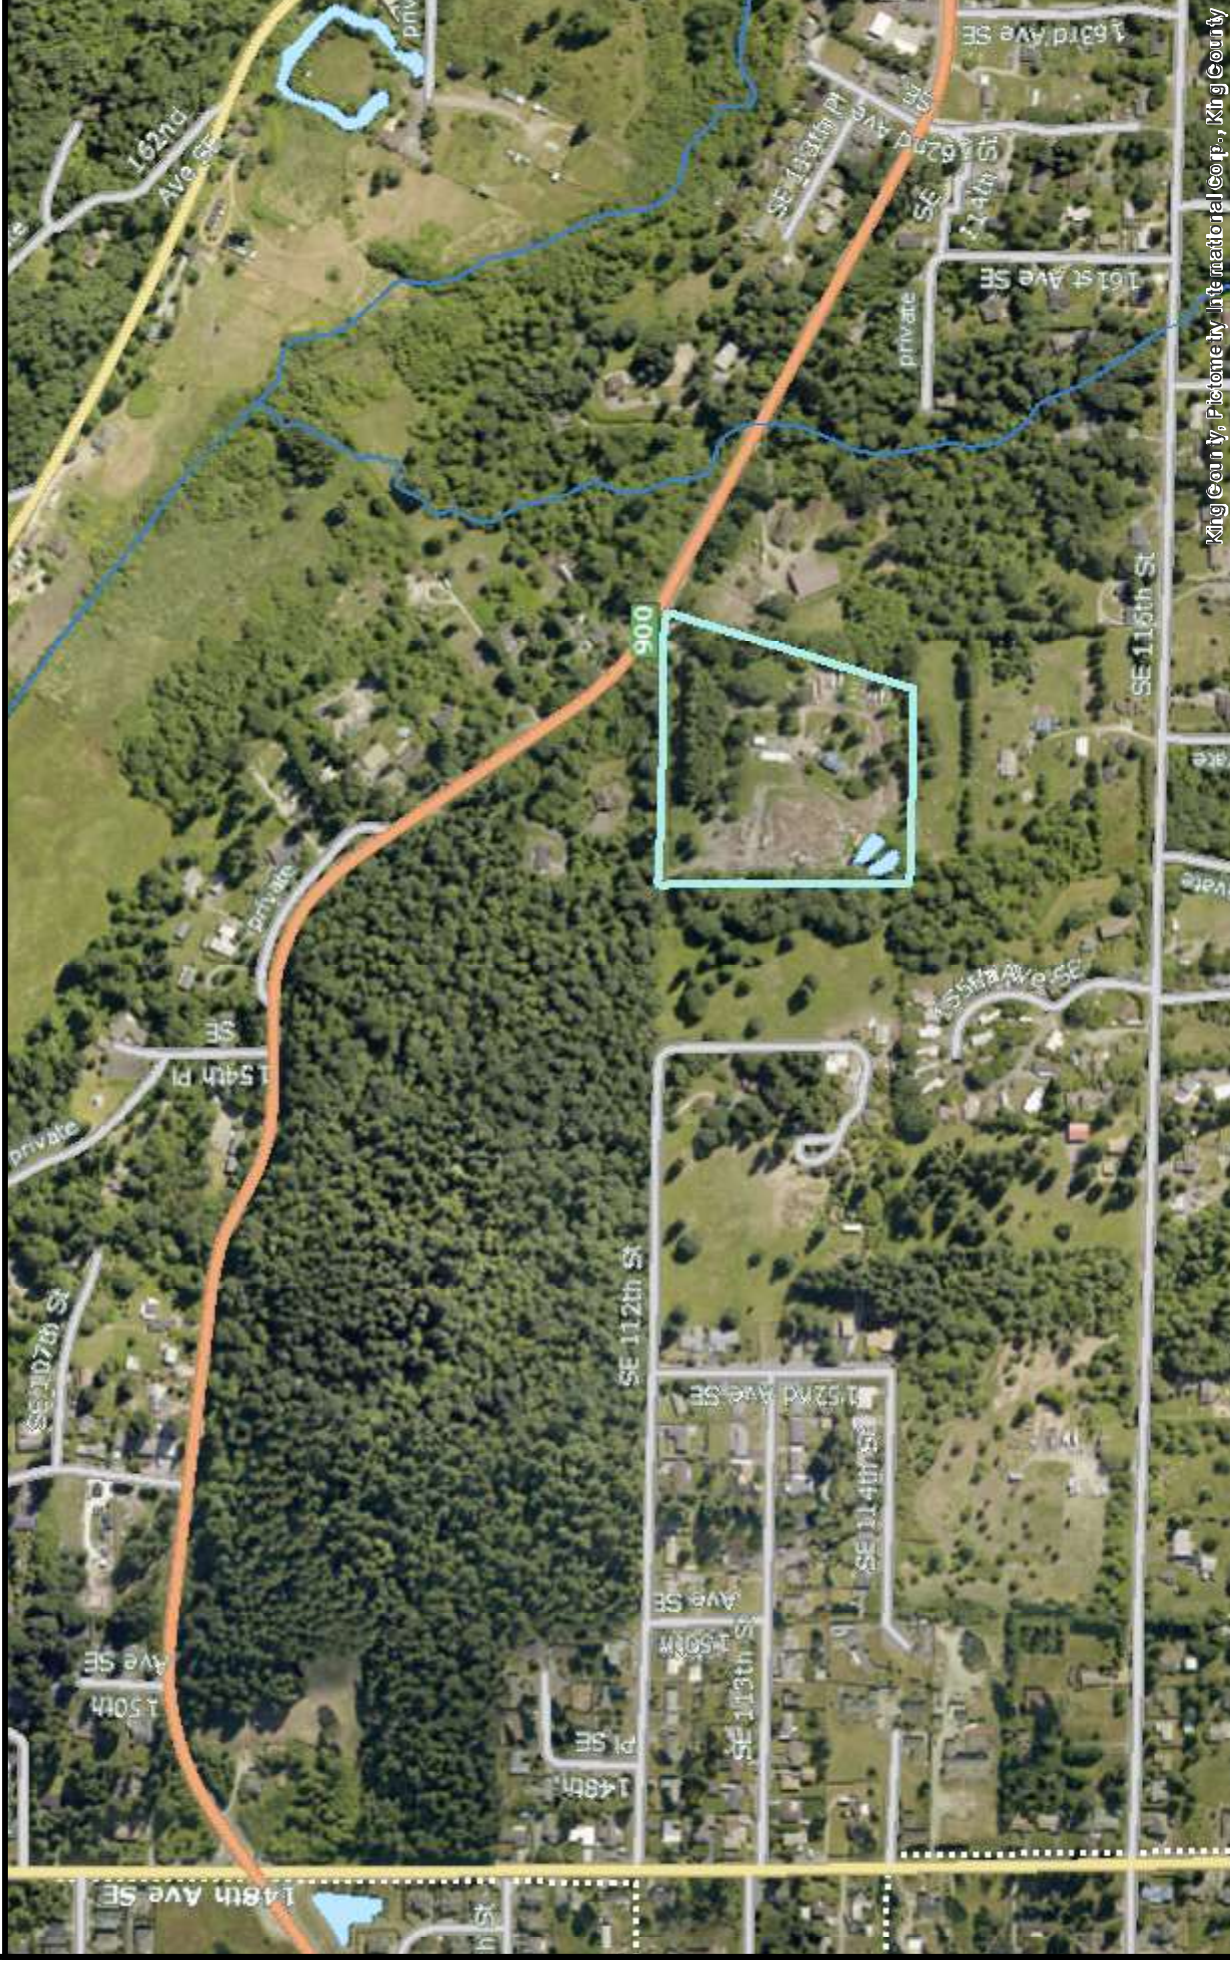
Figure 3. Pillon Property Aerial View

The parcel is 10 acres. A 3,080-square-foot, two-story house is south of the middle of the property. Accessory buildings include a carport and an equipment storage building. A large area of bare dirt west of the house is used for a variety of activities including dumping and burning of municipal and construction waste. Vehicles are stored east of the house on bare dirt. Public Health Seattle King County (PHSCK 2014) estimated that refuse disposal has occurred over 70 percent of the parcel (7 acres or 304,920 square feet) and up to 20 feet deep (6,098,400 cubic feet or 677,600 cubic yards). The edges of the property and the northeast corner are covered by grass and trees. Two ponds are located in the southwest corner of the property. Refuse has been observed in the ponds.

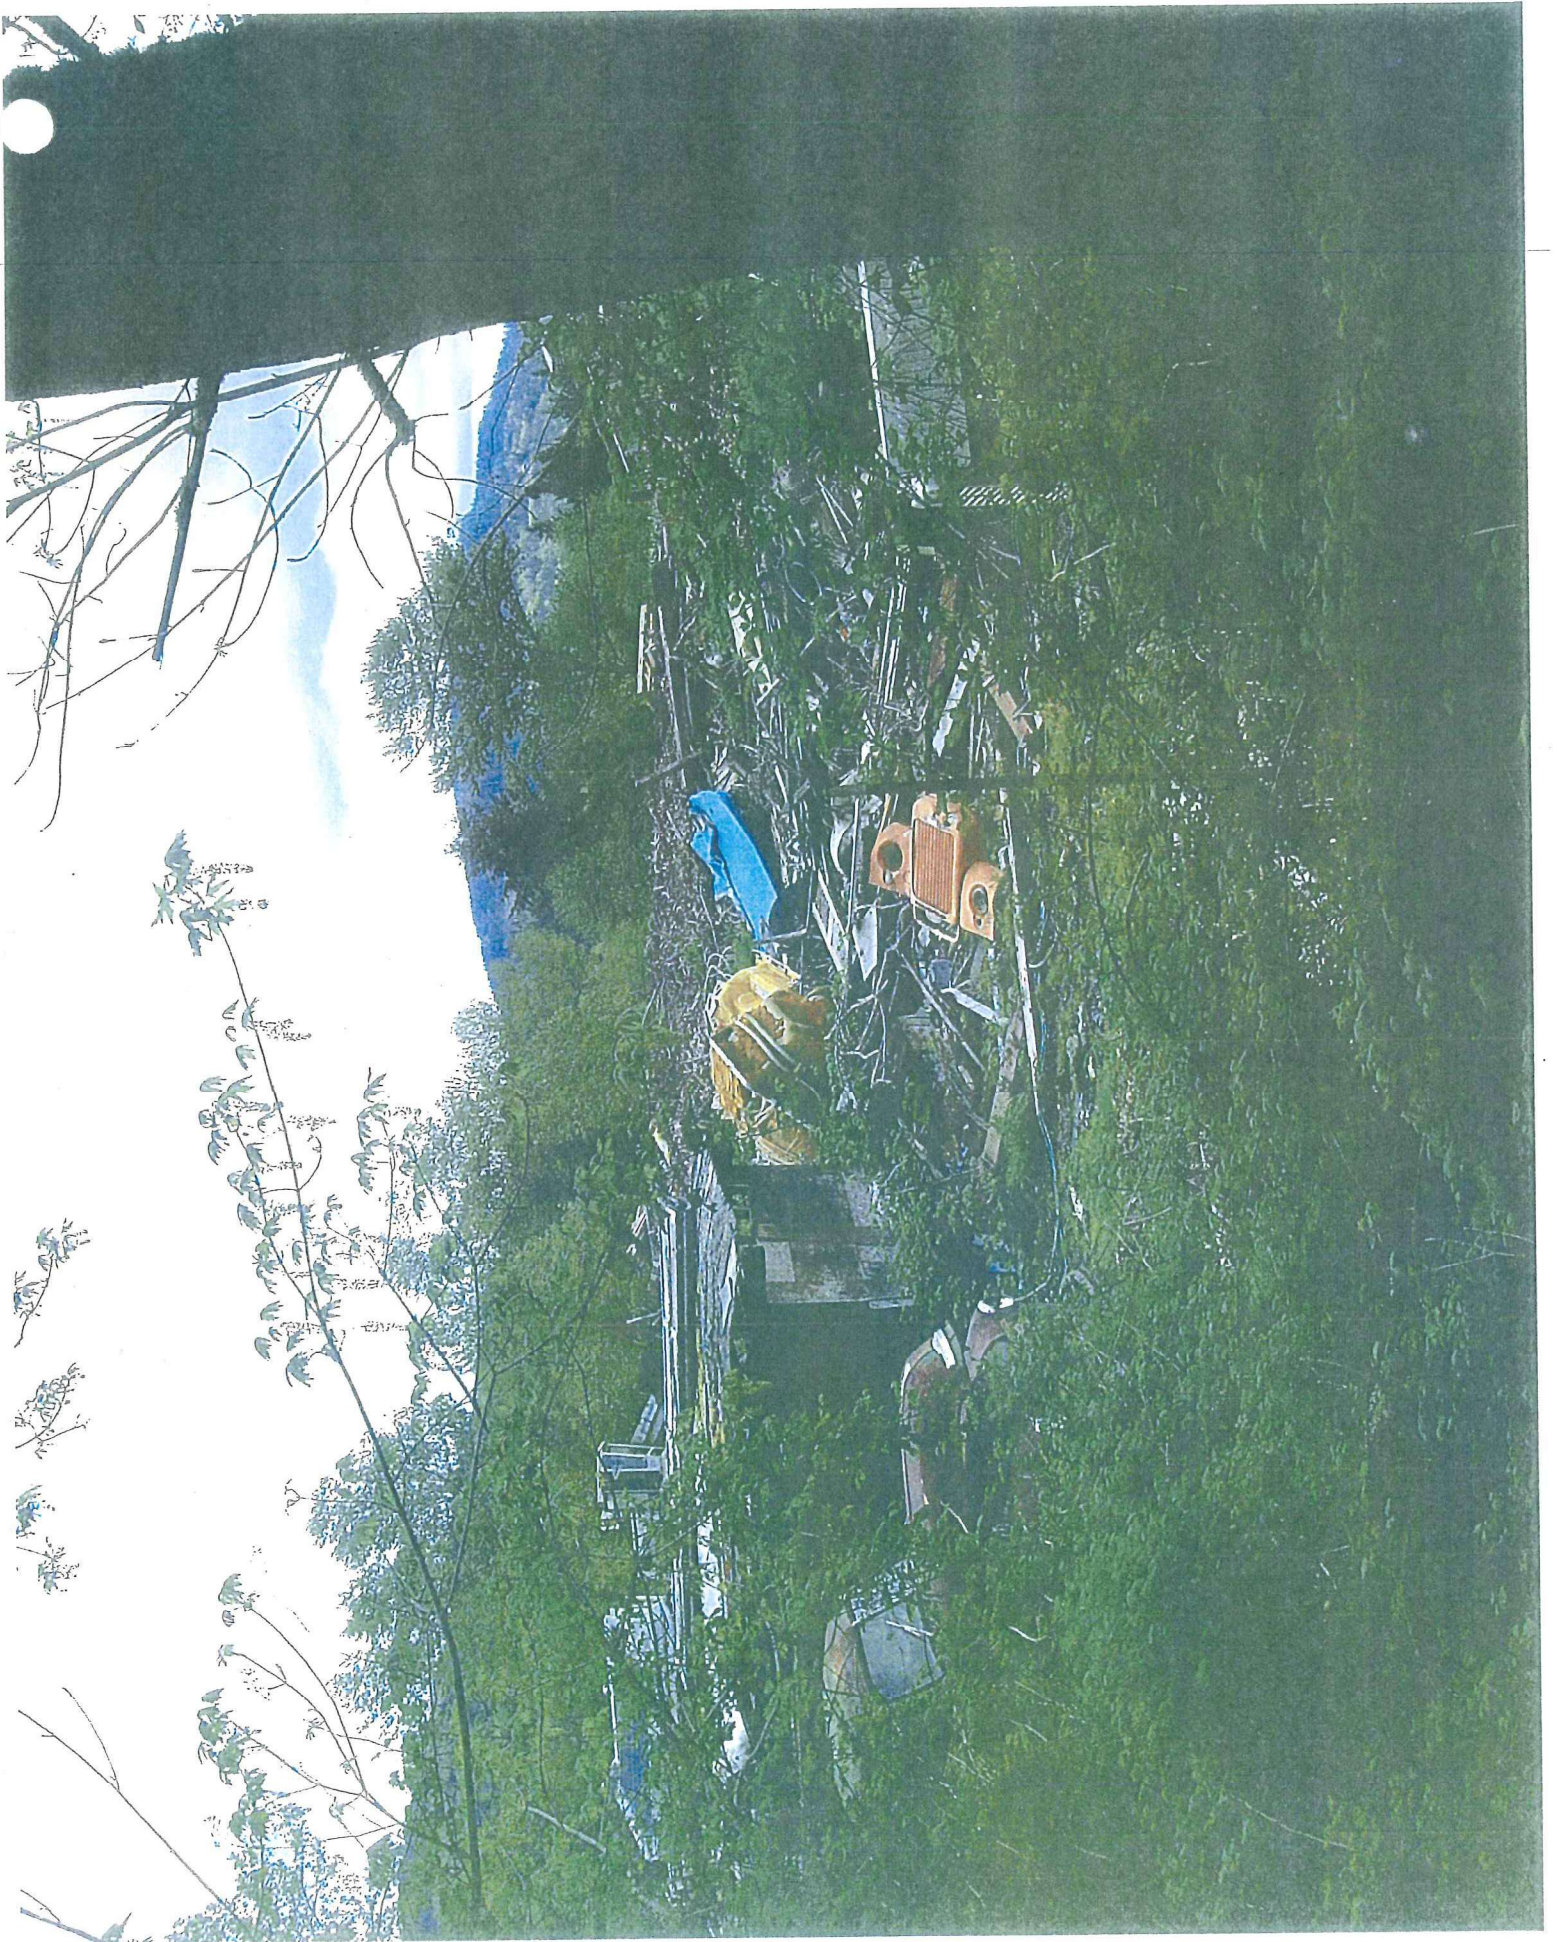
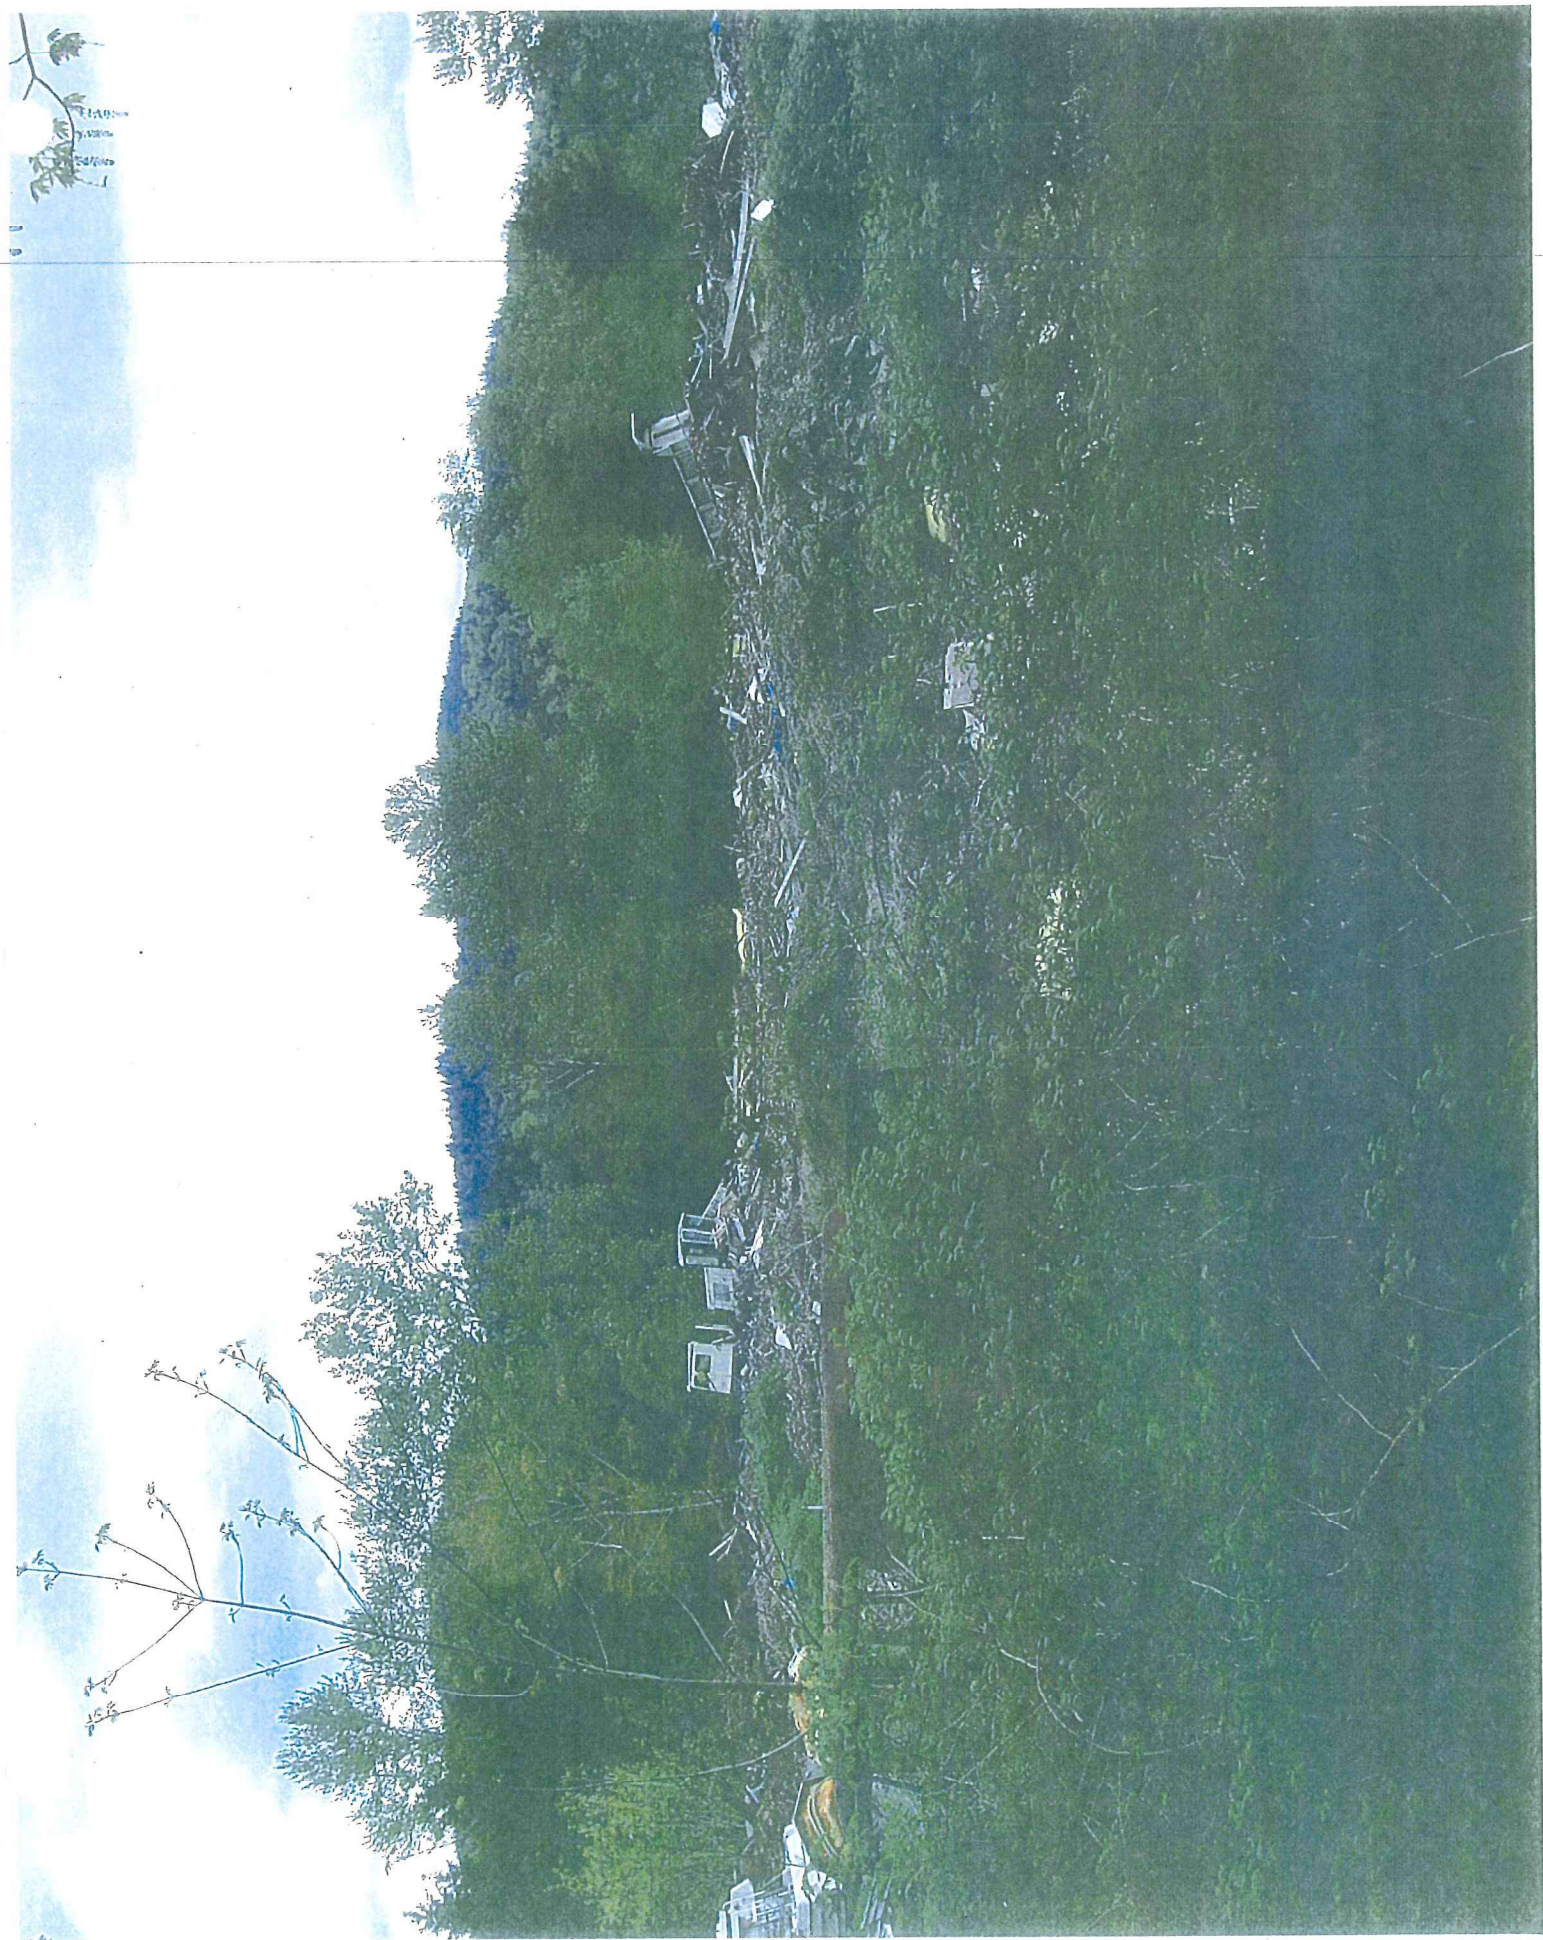
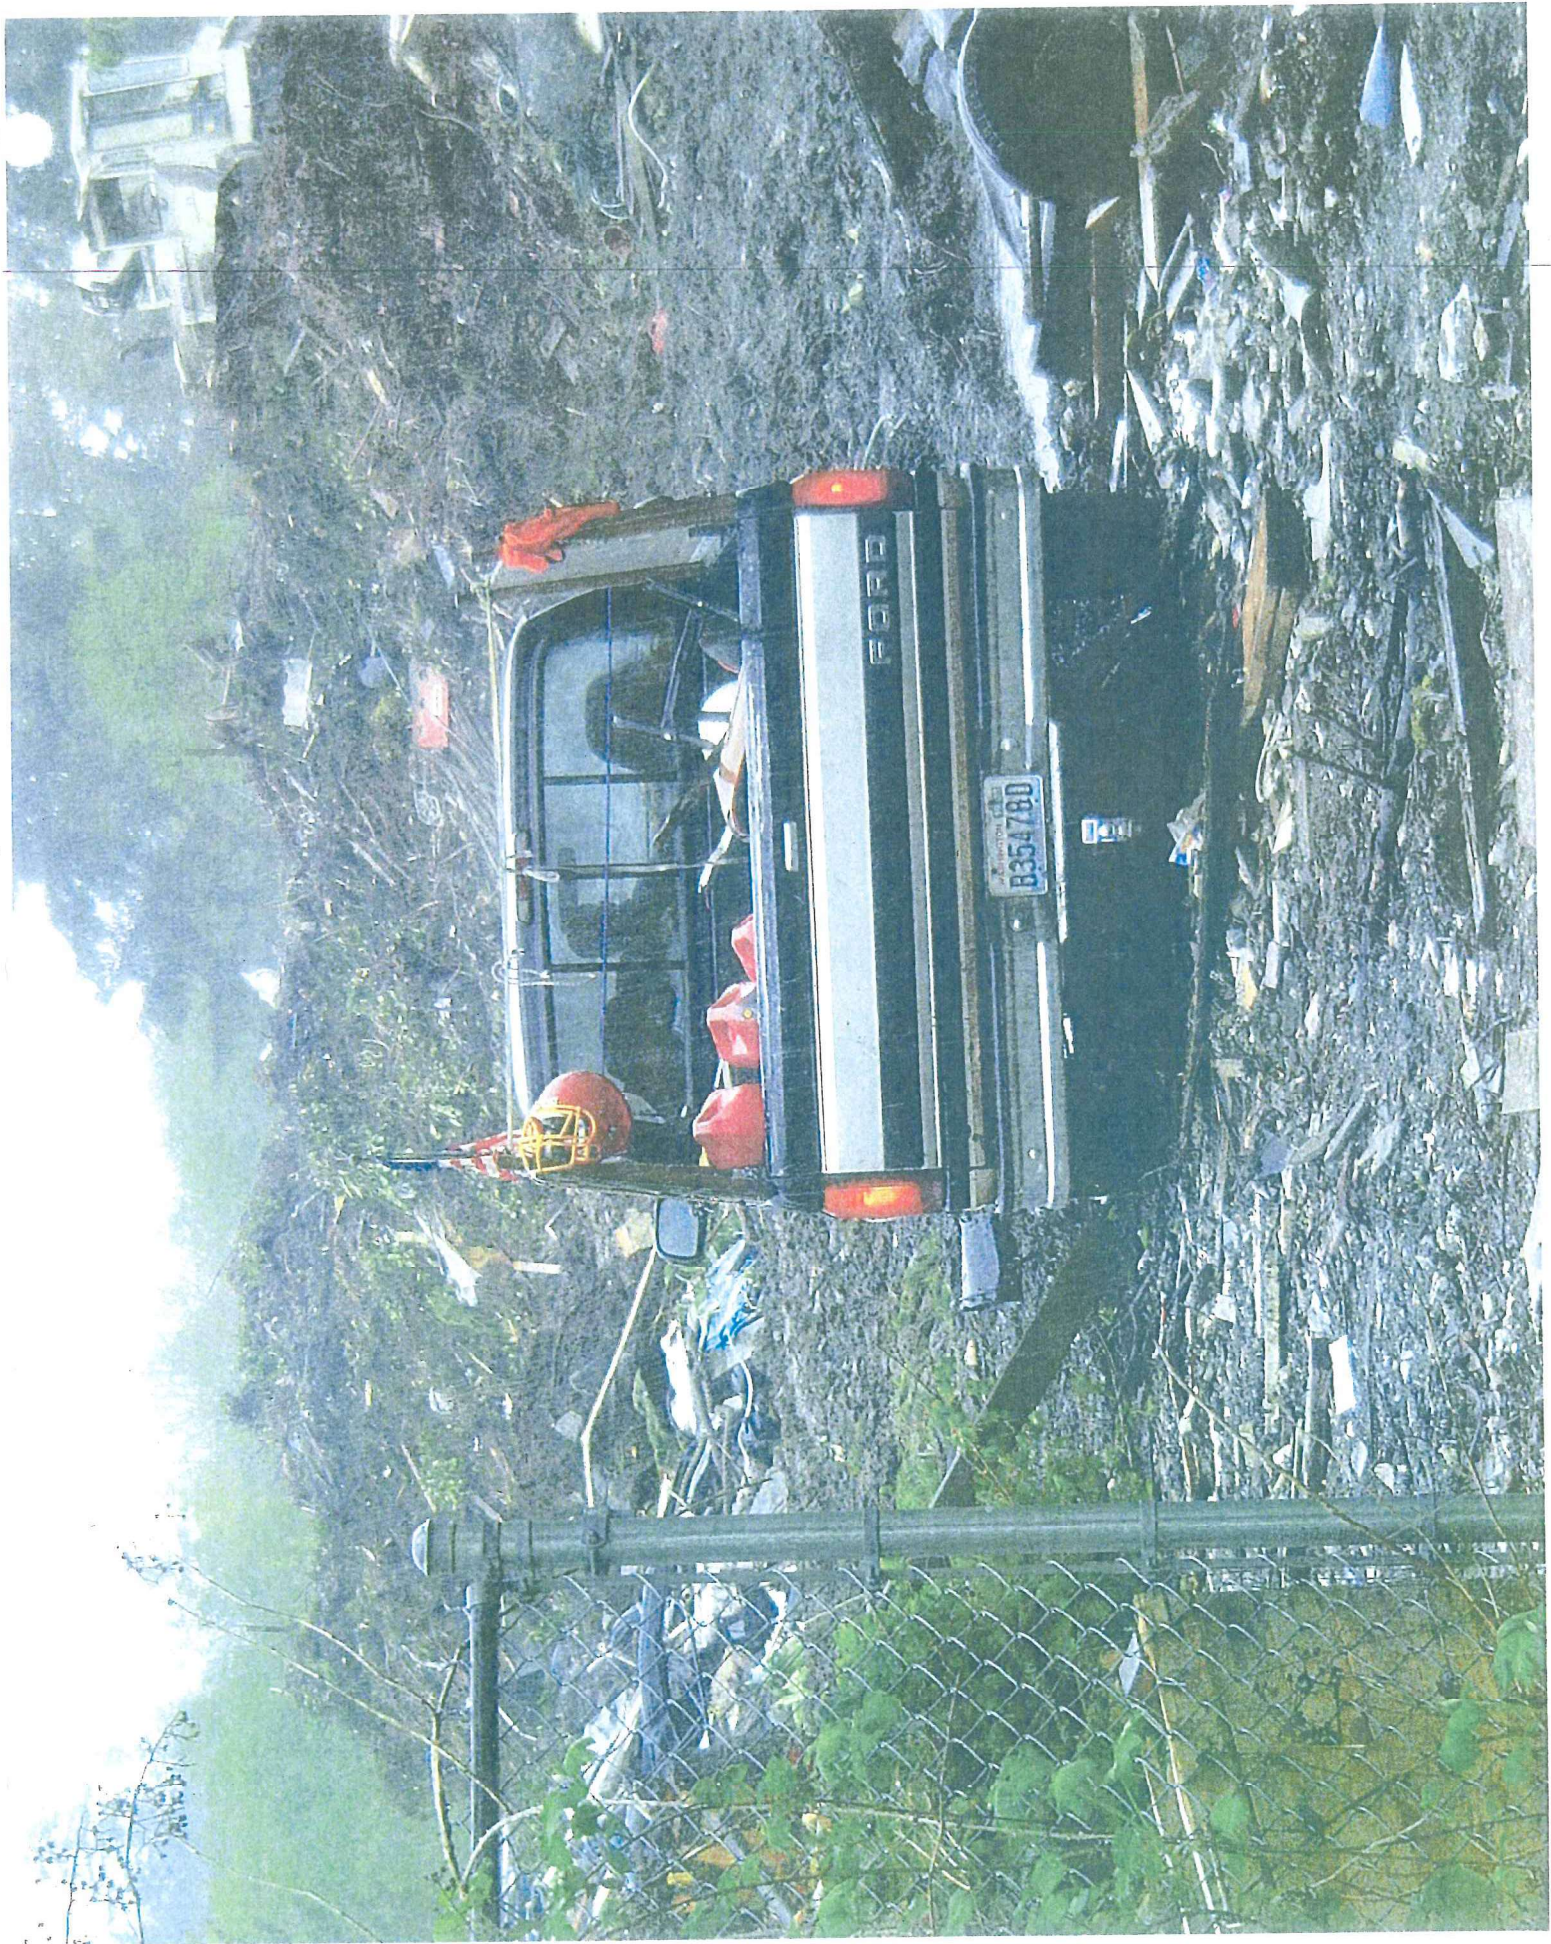
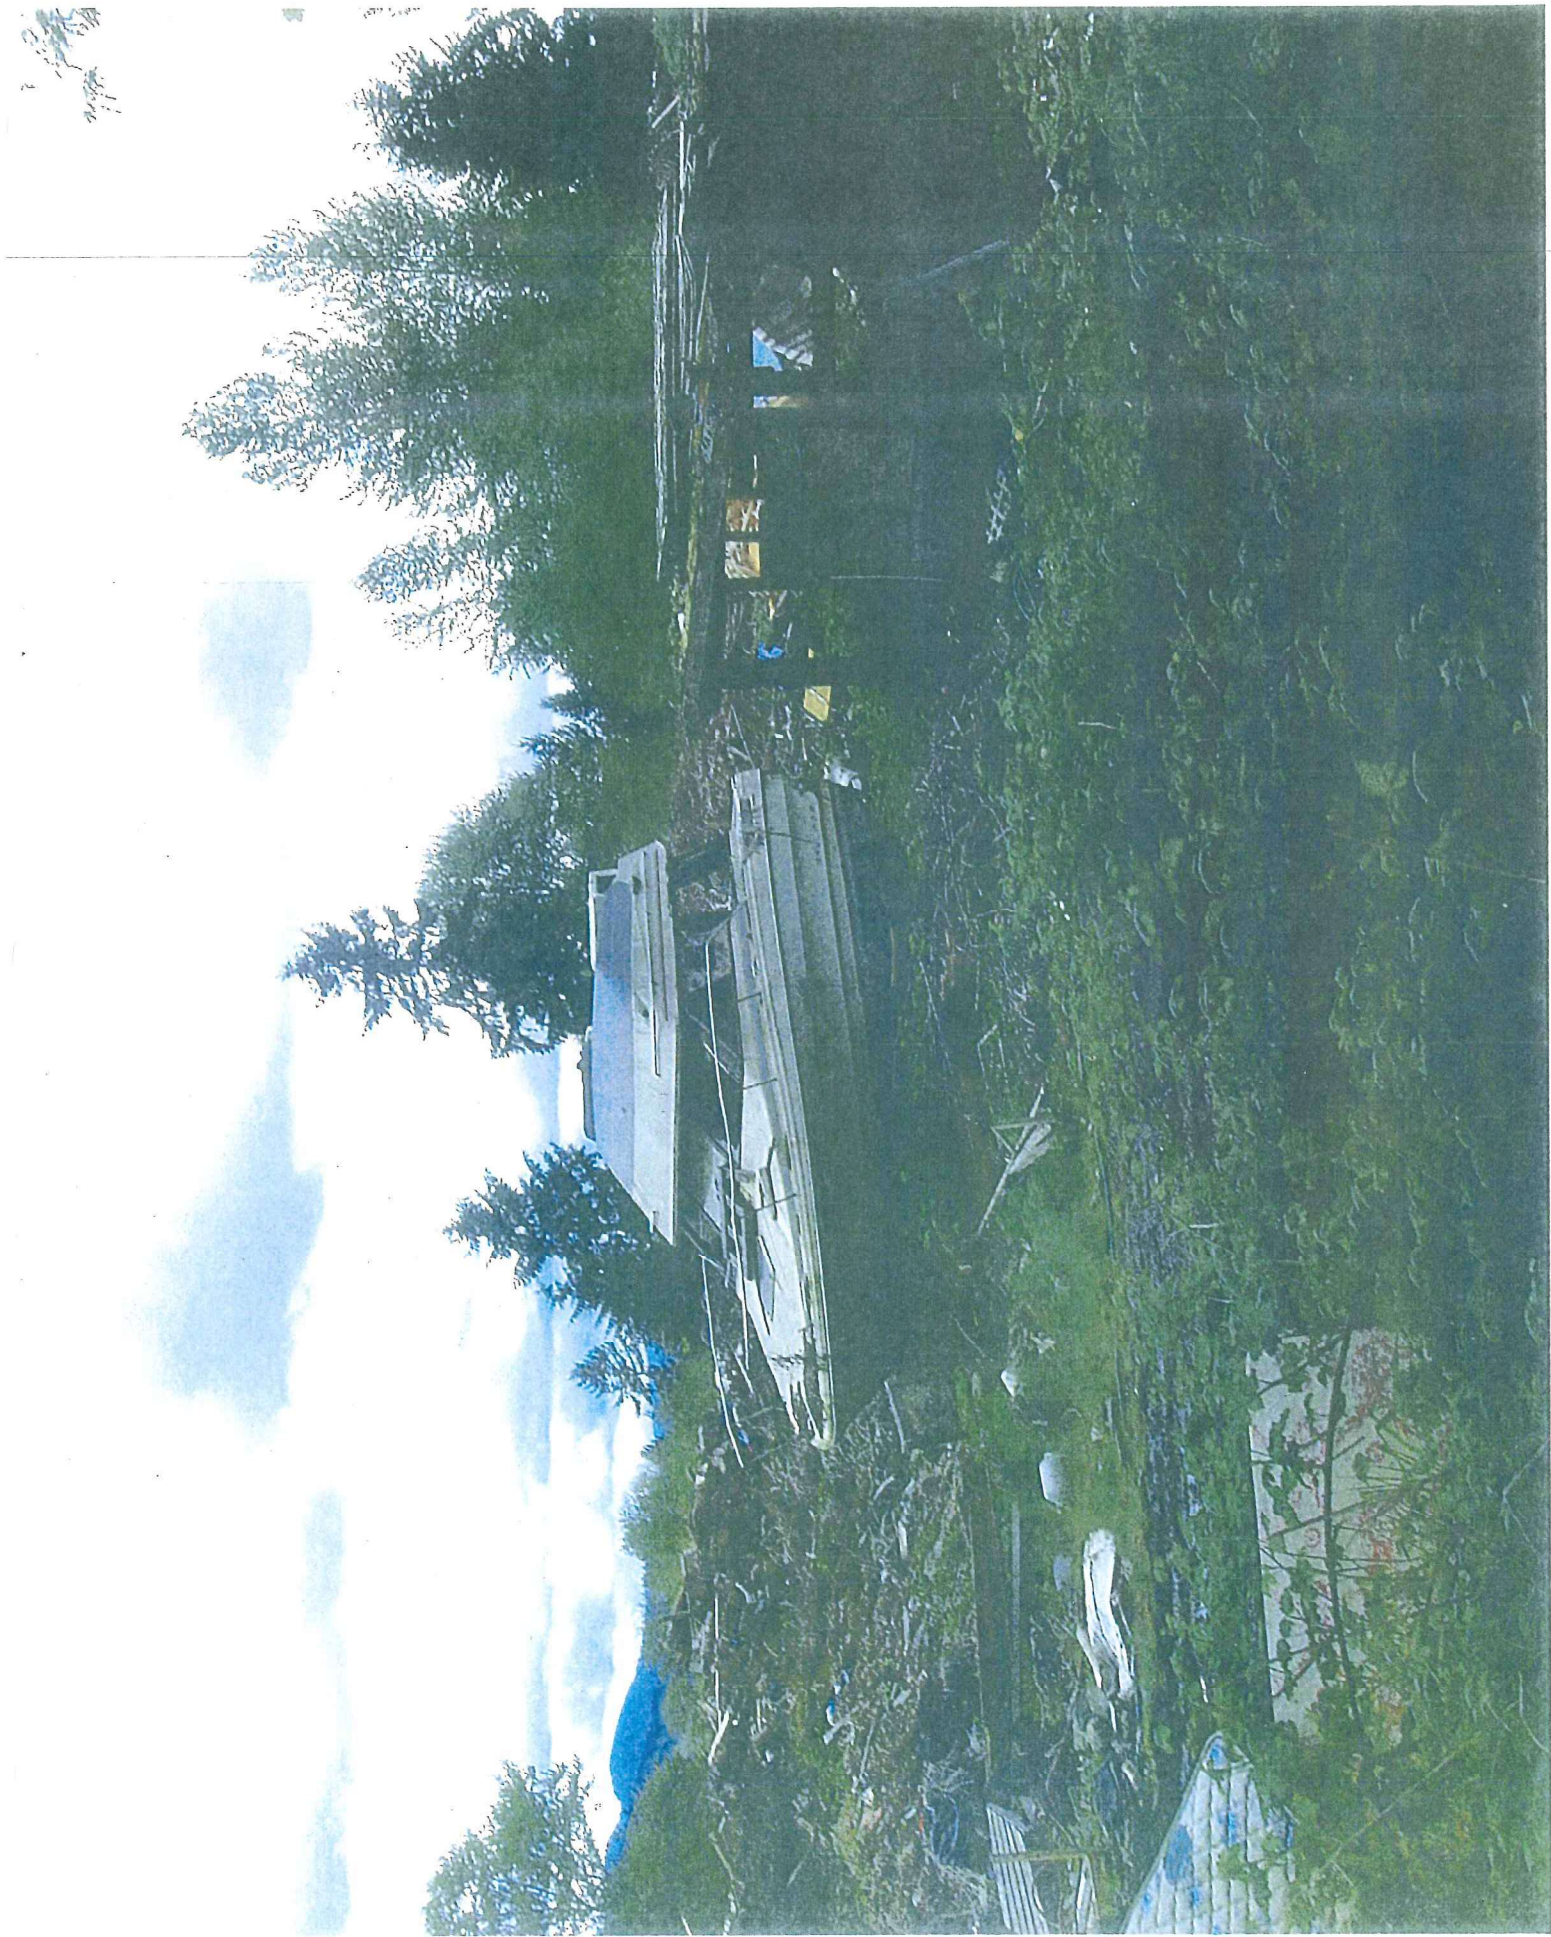
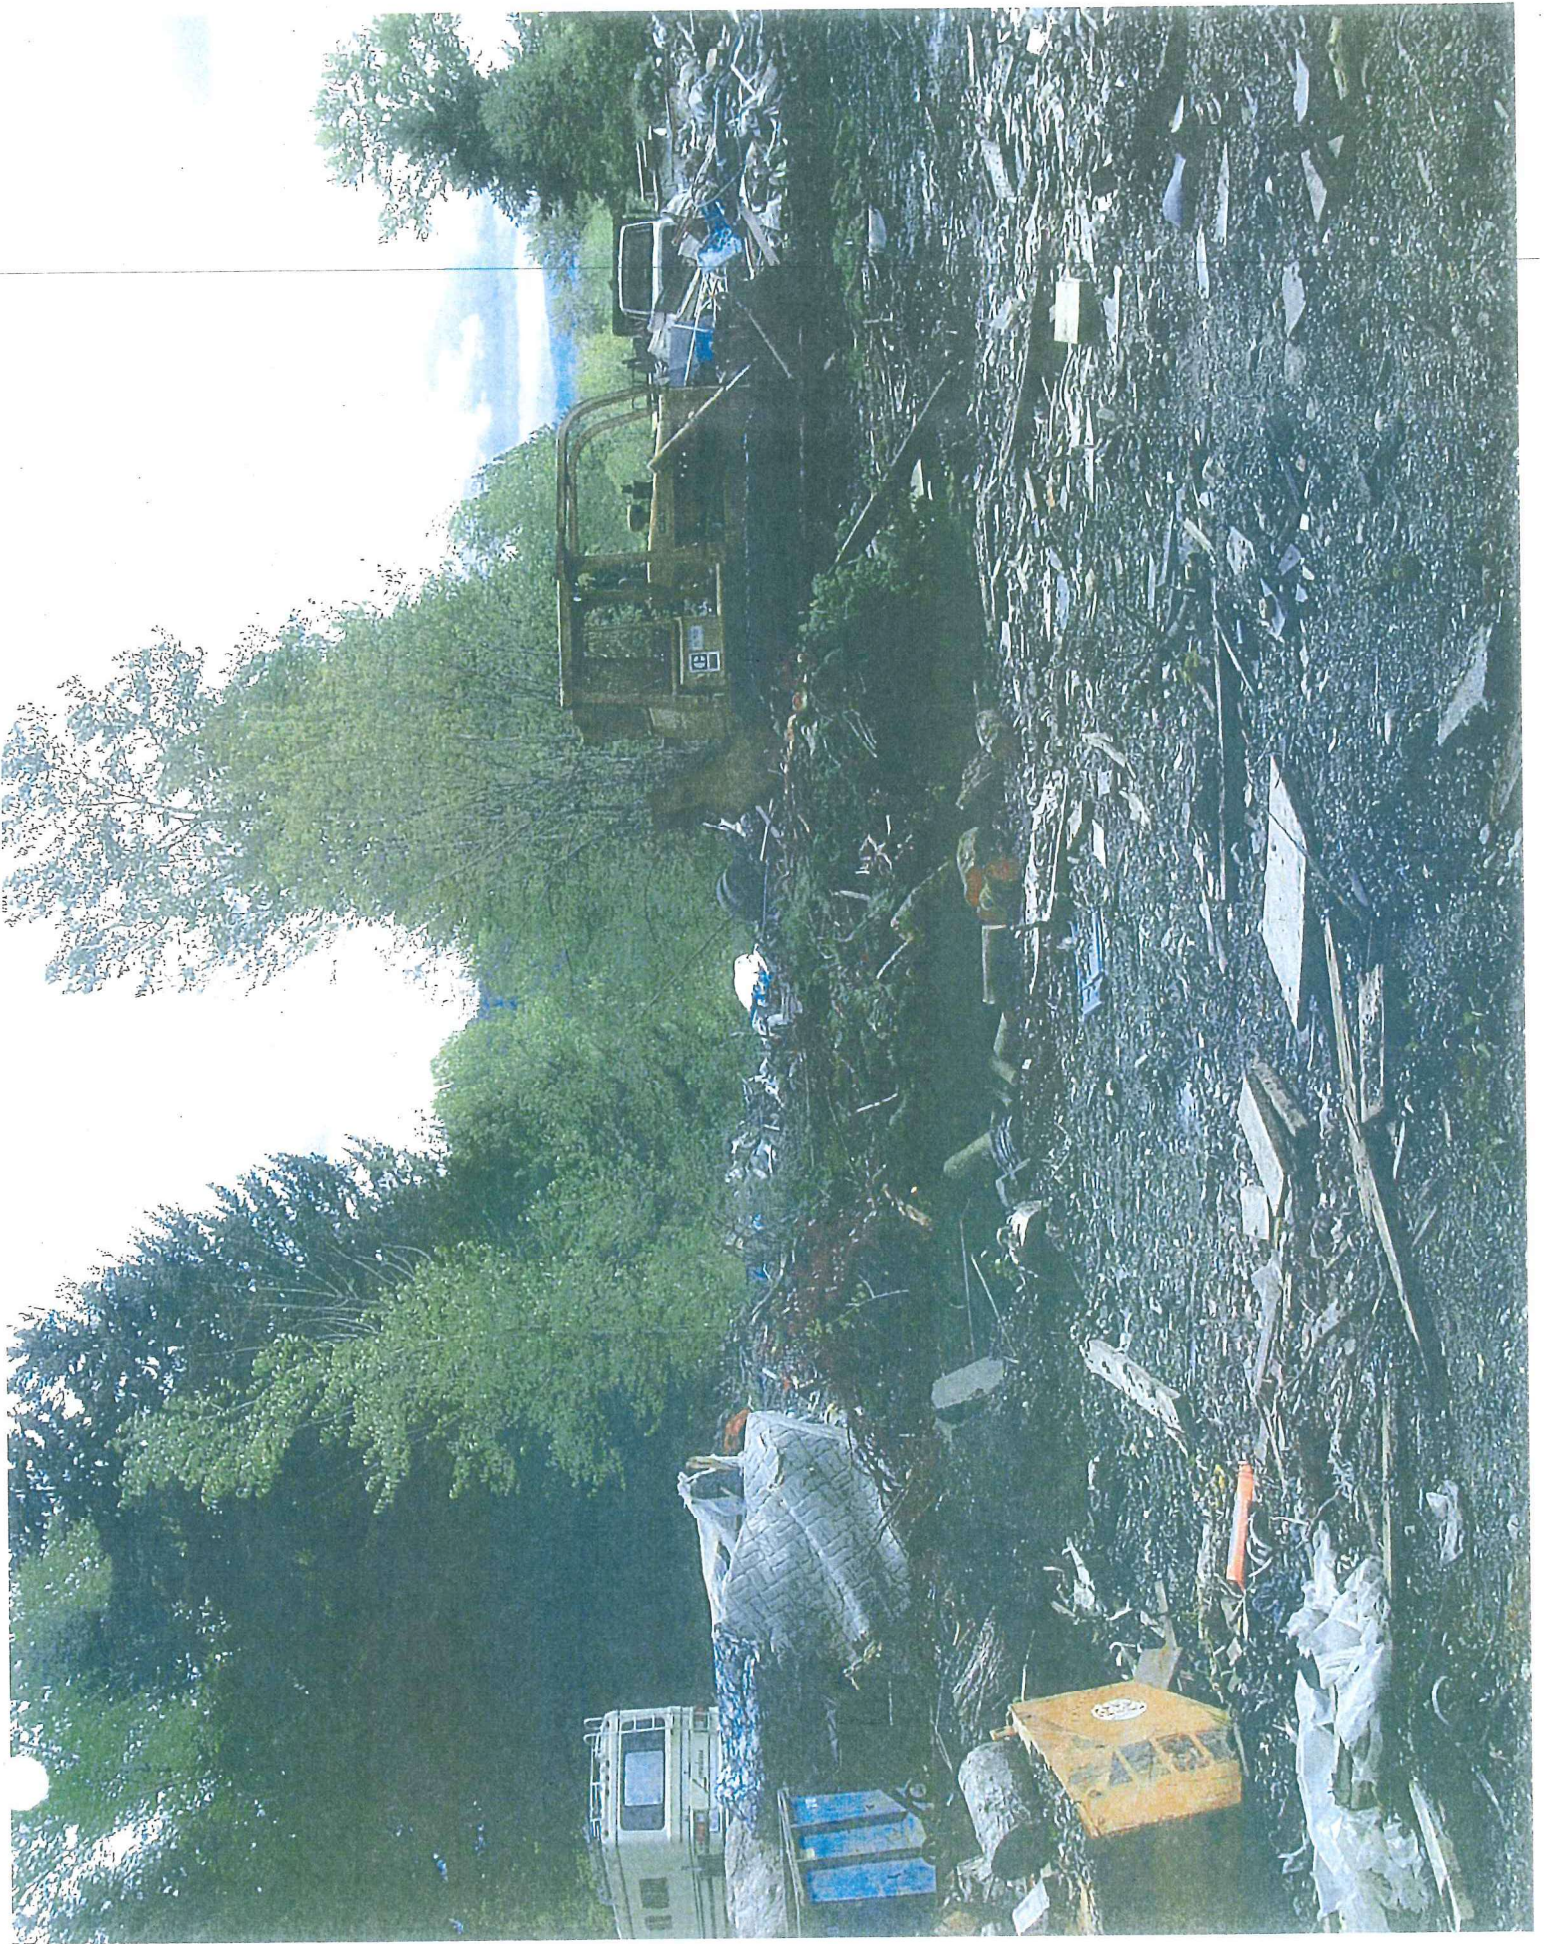
Figures 4-8. Photographs of the Pillon Property (courtesy of PHSKC)

A variety of wastes, summarized below, have been observed to be disposed on the Pillon property, buried and in piles. There are no liners below the waste and no landfill cover. Metals and petroleum hydrocarbons have been detected in surface water on the property (PHSKC 2014). Reports of burning and odors indicate confirmed releases to air. Observations of discolored soil on the property indicate the potential for releases to ground water.

Photographs of conditions on the Pillon property are provided at the end of this report. The photographs were obtained from Leonard DiToro, PHSKC.

- Site owner must immediately cease receiving waste, burning waste, smelting metals, and landfilling.
- The site must be cleaned up.
- PHSKC planned to perform a well survey because of concerns about neighbors drinking potentially contaminated ground water. (To date, the well survey has not been conducted.)
- Additional sampling of soil, sediment, ground water, and surface water should be performed, with analyses for a full suite of chemicals, including metals, volatile and semivolatile organic compounds, PAHs, polybrominated diphenyl ethers, petroleum hydrocarbons, chlorofluorohydrocarbons, and pesticides.
